TS-PIC-9805549R/9905549R
November 1998

AERIAL PHOTOGRAPHIC ANALYSIS MIDWEST METALLICS SITE Summit, Illinois

S. A. Shepard
Environmental Services Division
Lockheed Environmental Systems & Technologies Co.
Las Vegas, Nevada 89119

J. L. Bozik
Landscape Ecology Branch
Environmental Sciences Division
Las Vegas, Nevada 89193-3478

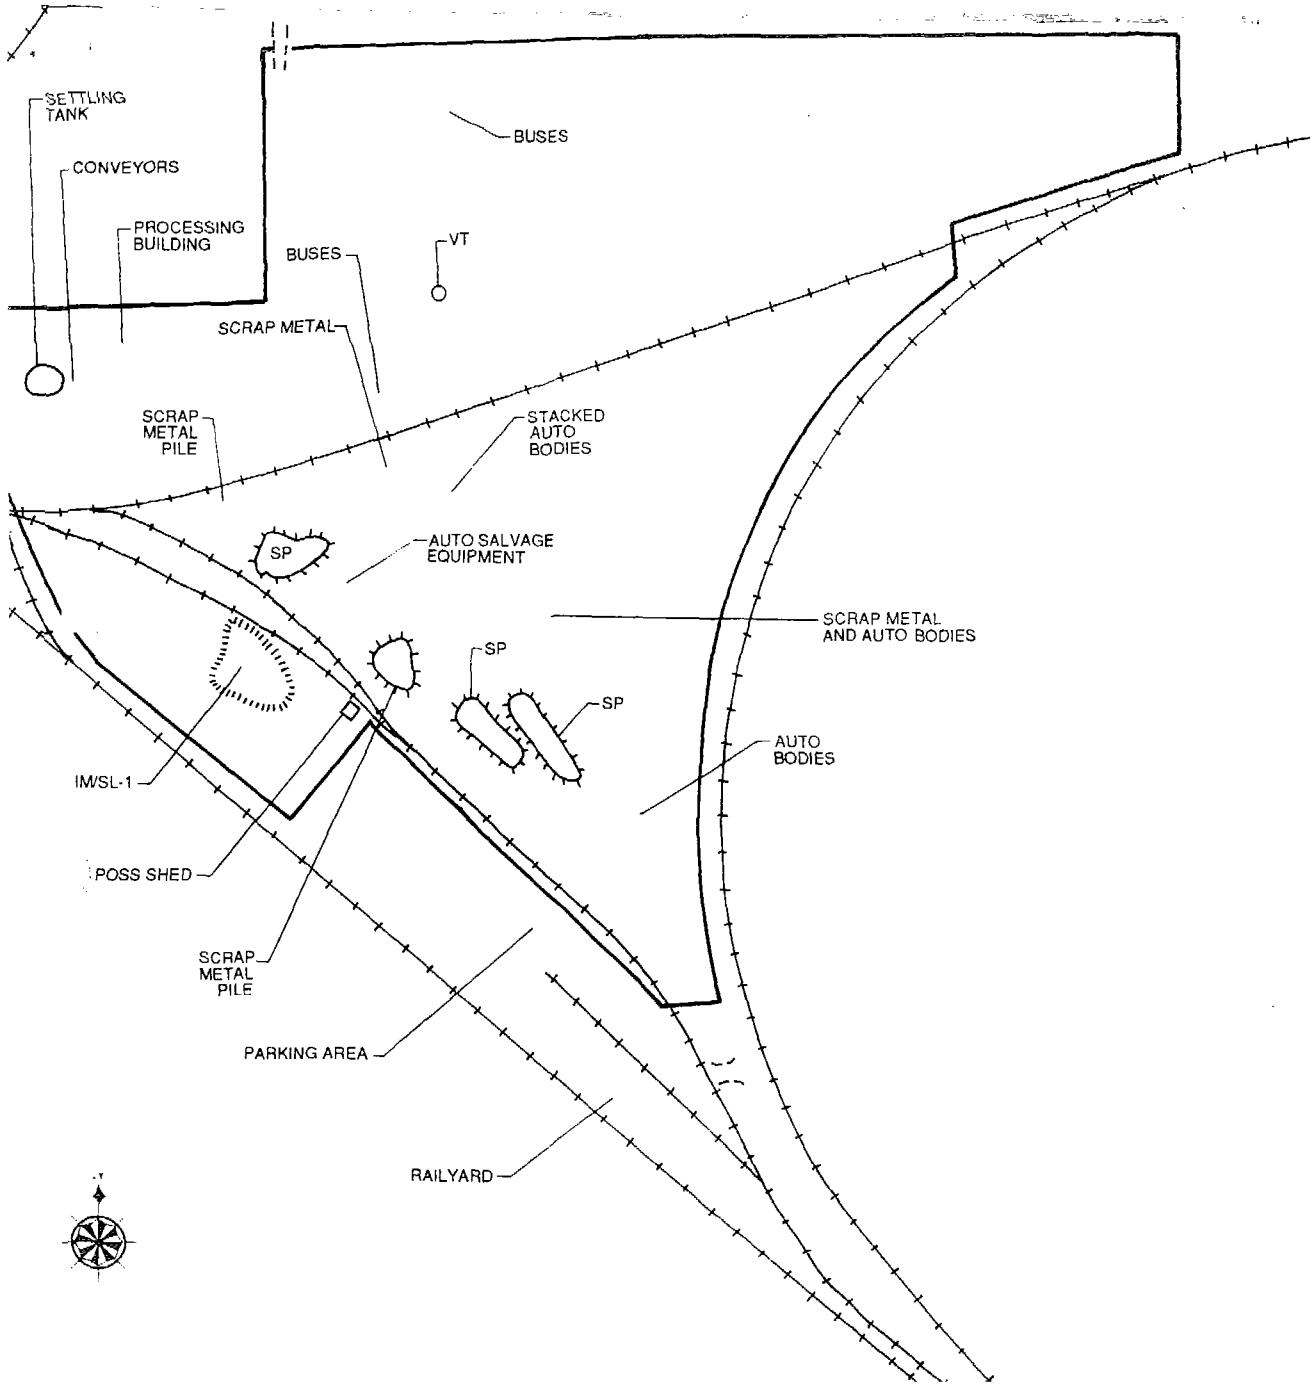
Midwest Metallics site, April 7, 1976. Approximate scale 1:3,000.

APRIL 7, 1976 (FIGURE 3)

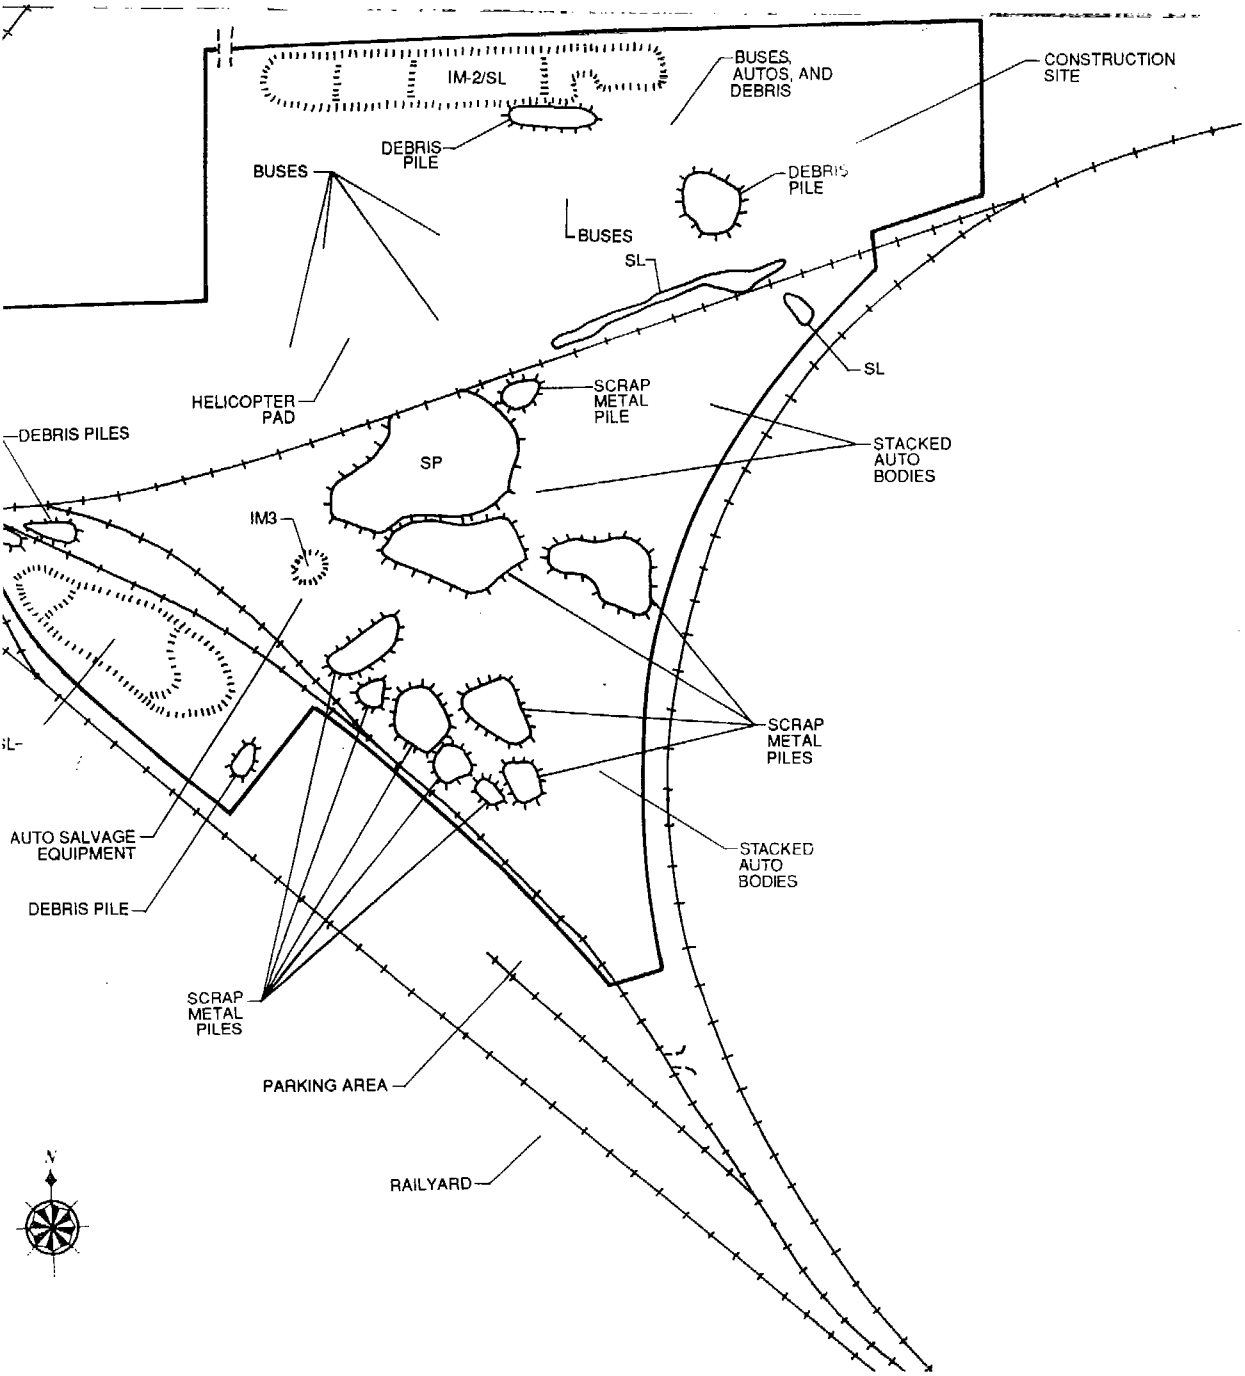
Midwest Metallics site, November 22, 1980. Approximate scale 1:3,100.

The site continues to be in operation. A liquid-filled impoundment (IM-2/SL) is present along the northern boundary of the site. A construction site is present at the northeast corner of the site. The liquid-filled impoundment IM-1/SL has increased in size since 1976 and now contains three cells. Another dry impoundment (IM-3) is present north of the automobile salvage equipment. Several areas of standing liquid (SL) have formed in the locations of depressions on the site. These areas of standing liquid will be annotated but not discussed.

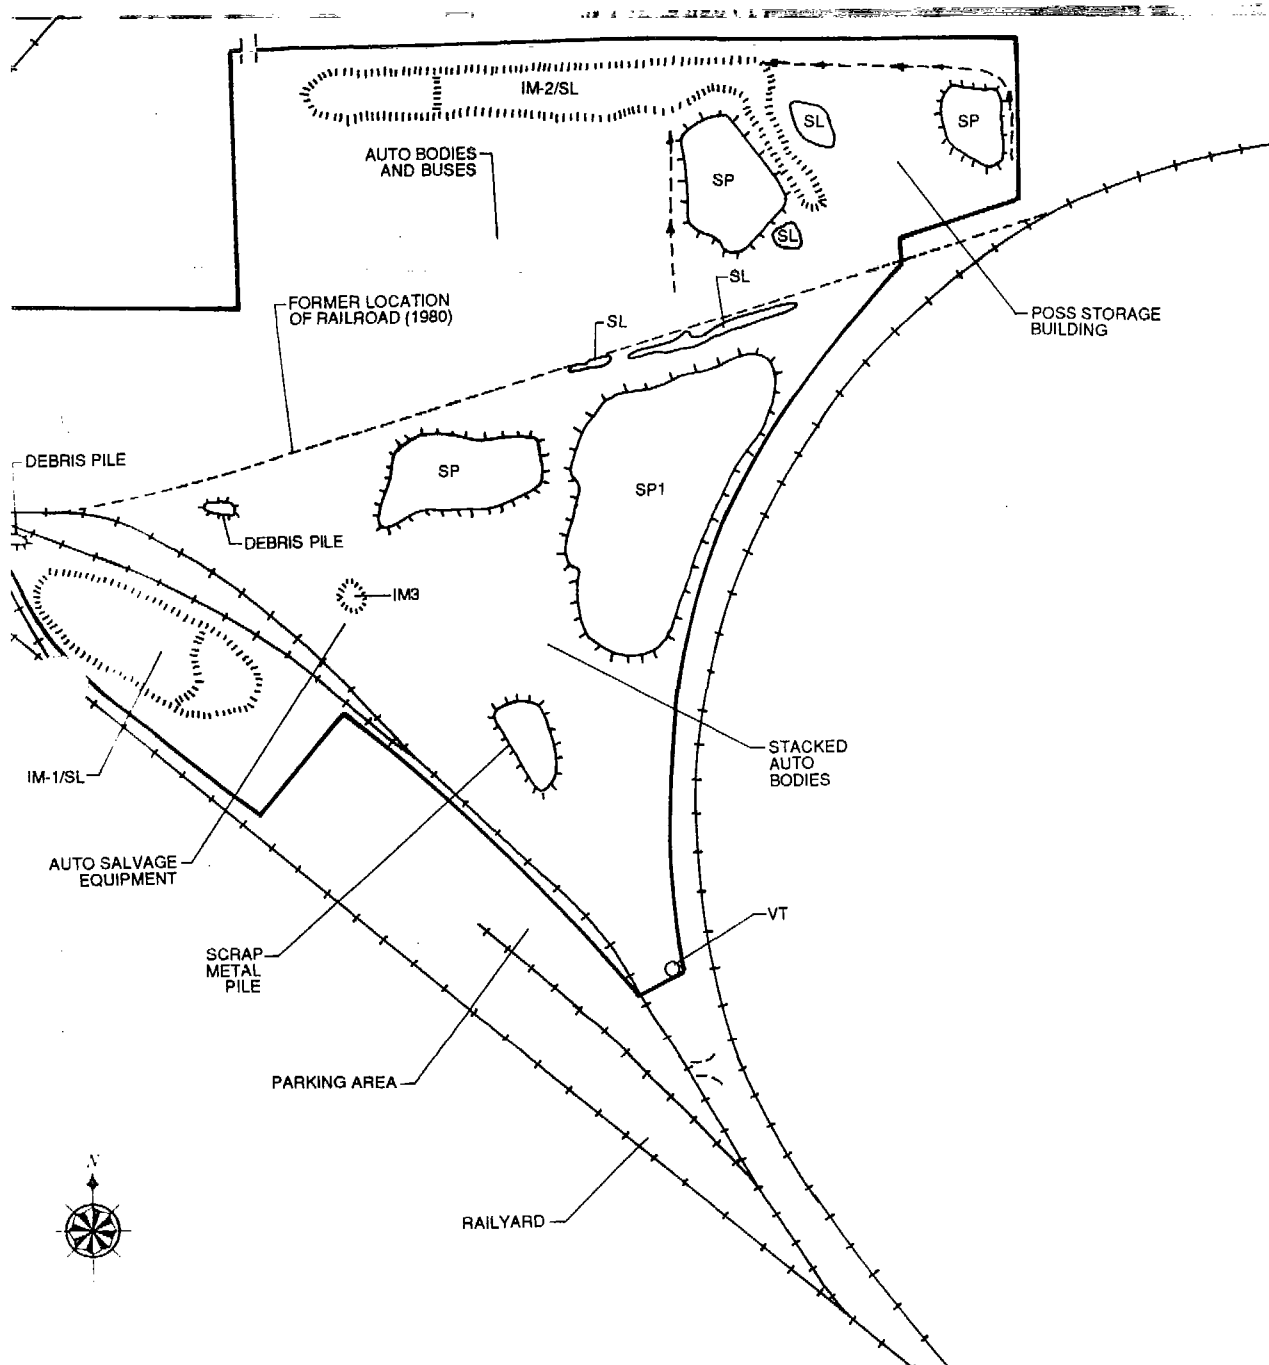
The site continues to be in operation. The liquid-filled impoundment IM-2/SL has increased in size since 1980. Drainage patterns are now present; one channel trending north and the other trending west, both into a liquid-filled impoundment (IM-2/SL). A possible storage building has been completed in the northeast corner of the site where construction was observed in 1980. The liquid-filled impoundment IM-1/SL now contains only two cells and no changes are observed in impoundment IM-3. Storage pile SP1 (a pile with a medium tone and grainy surface), the primary feature of interest in this analysis, is noted for the first time along the eastern boundary of the site.

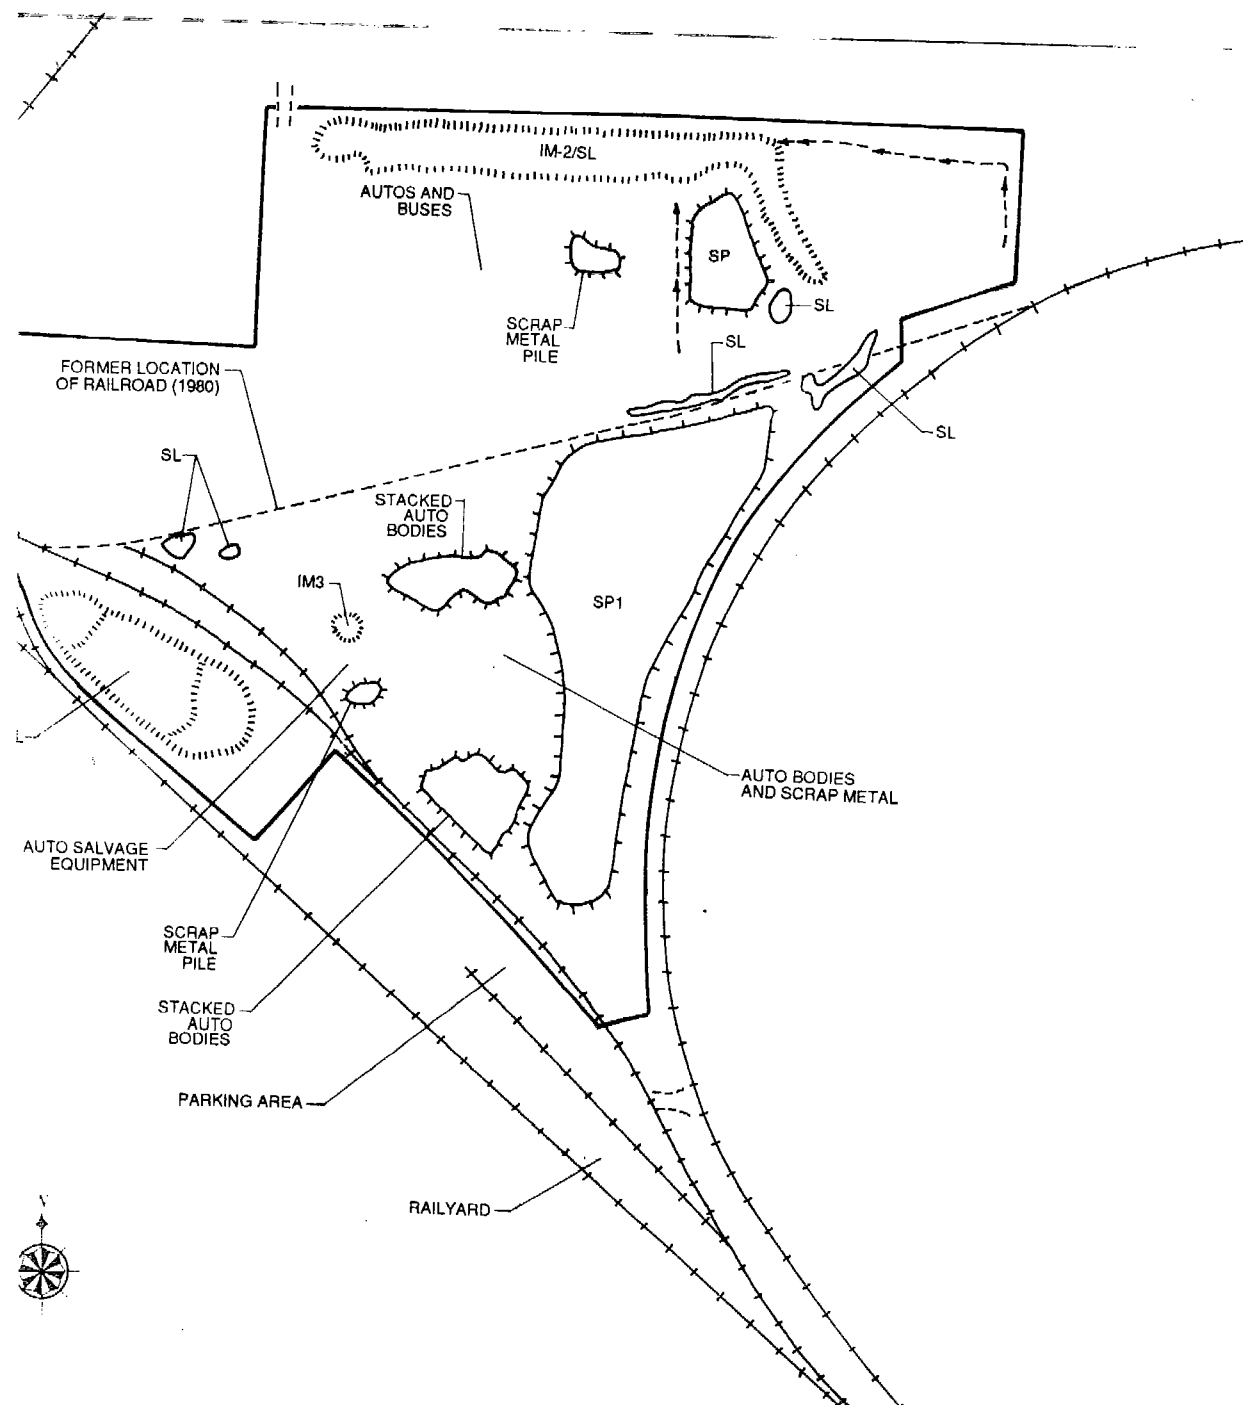
Midwest Metallics site, April 7, 1988. Approximate scale 1:3,400.

The site continues to be in operation. Liquid-filled impoundment IM-1/SL again contains three cells. No changes are noted in liquid-filled impoundment IM-1/SL or impoundment IM-3. New material has been added to storage pile SP1 and has approximately doubled in size since 1987.

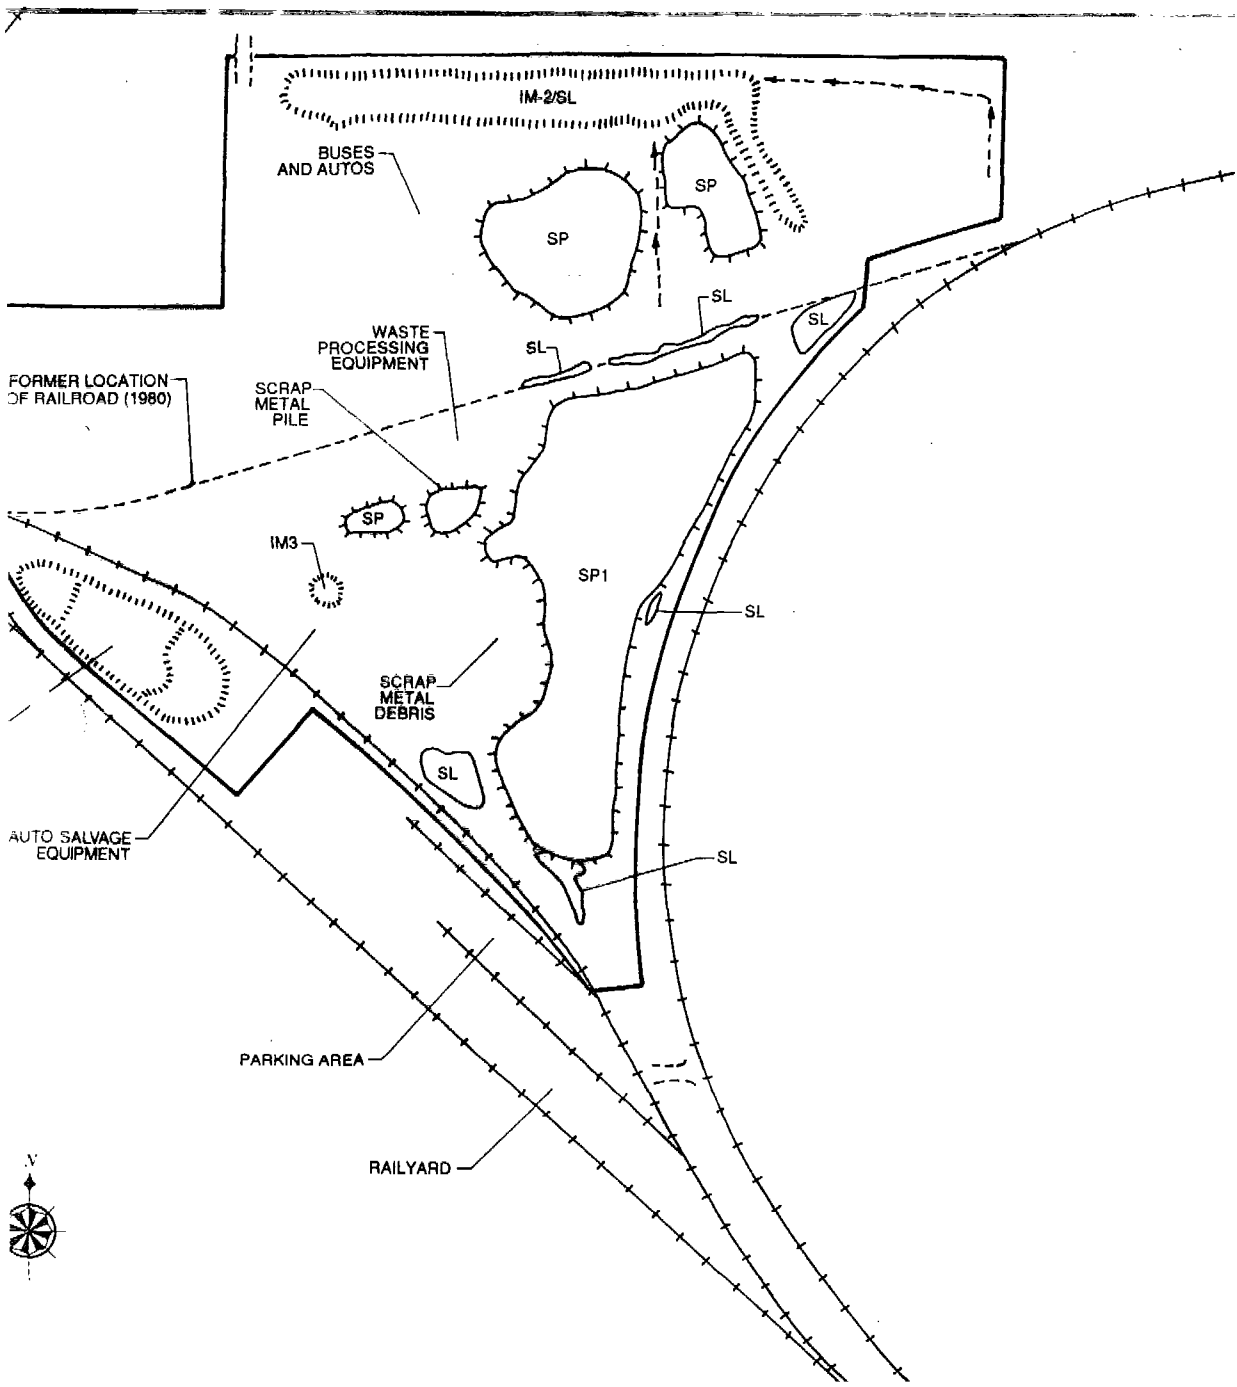
Midwest Metallics site, March 20, 1990. Approximate scale 1:3,103.

The site continues to be in operation. No changes are noted in liquid-filled impoundments IM-1/SL and IM-2/SL or impoundment IM-3. Storage pile (SP1) has changed in shape since 1988. New waste processing equipment is visible south of the former location of the railroad.

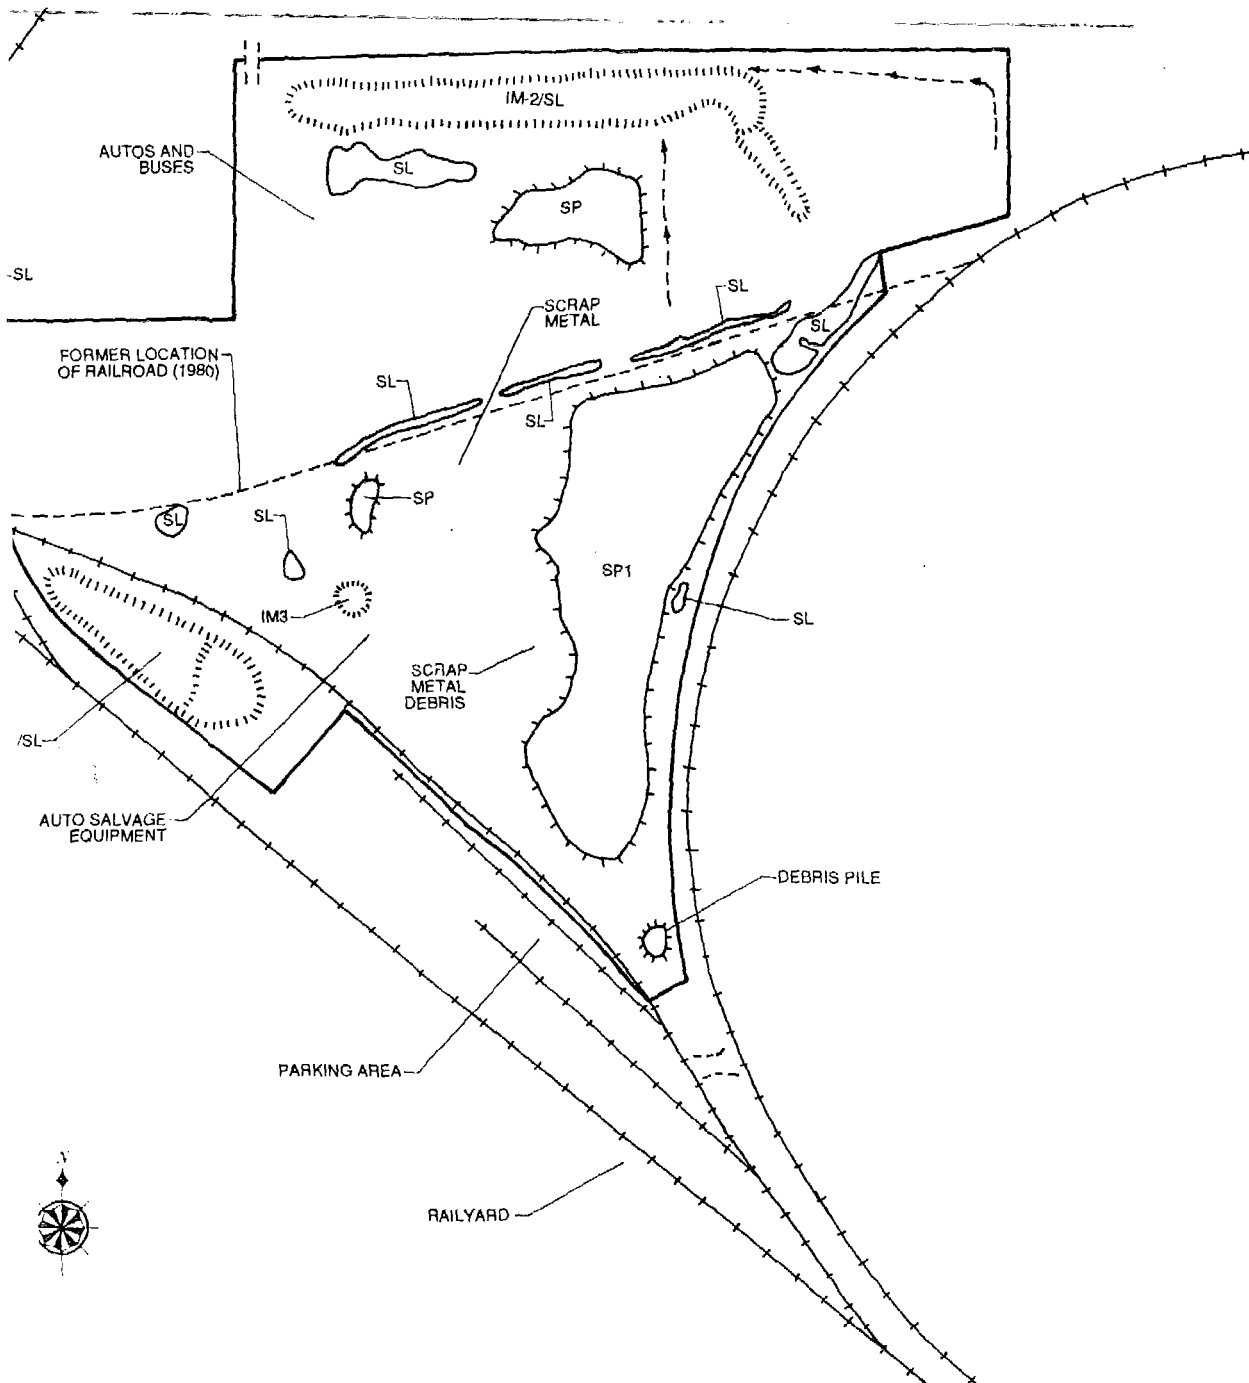
Midwest Metallics site, May 1, 1993. Approximate scale 1:2,100.

The site continues to be in operation. Liquid-filled impoundment IM-2/SL now contains two cells. The waste processing equipment noted south of the former railroad in 1990 has been removed. Liquid-filled impoundment IM-1/SL now contains two cells. No changes are noted in impoundment IM-3. Storage pile SP1 has changed in configuration since 1990.

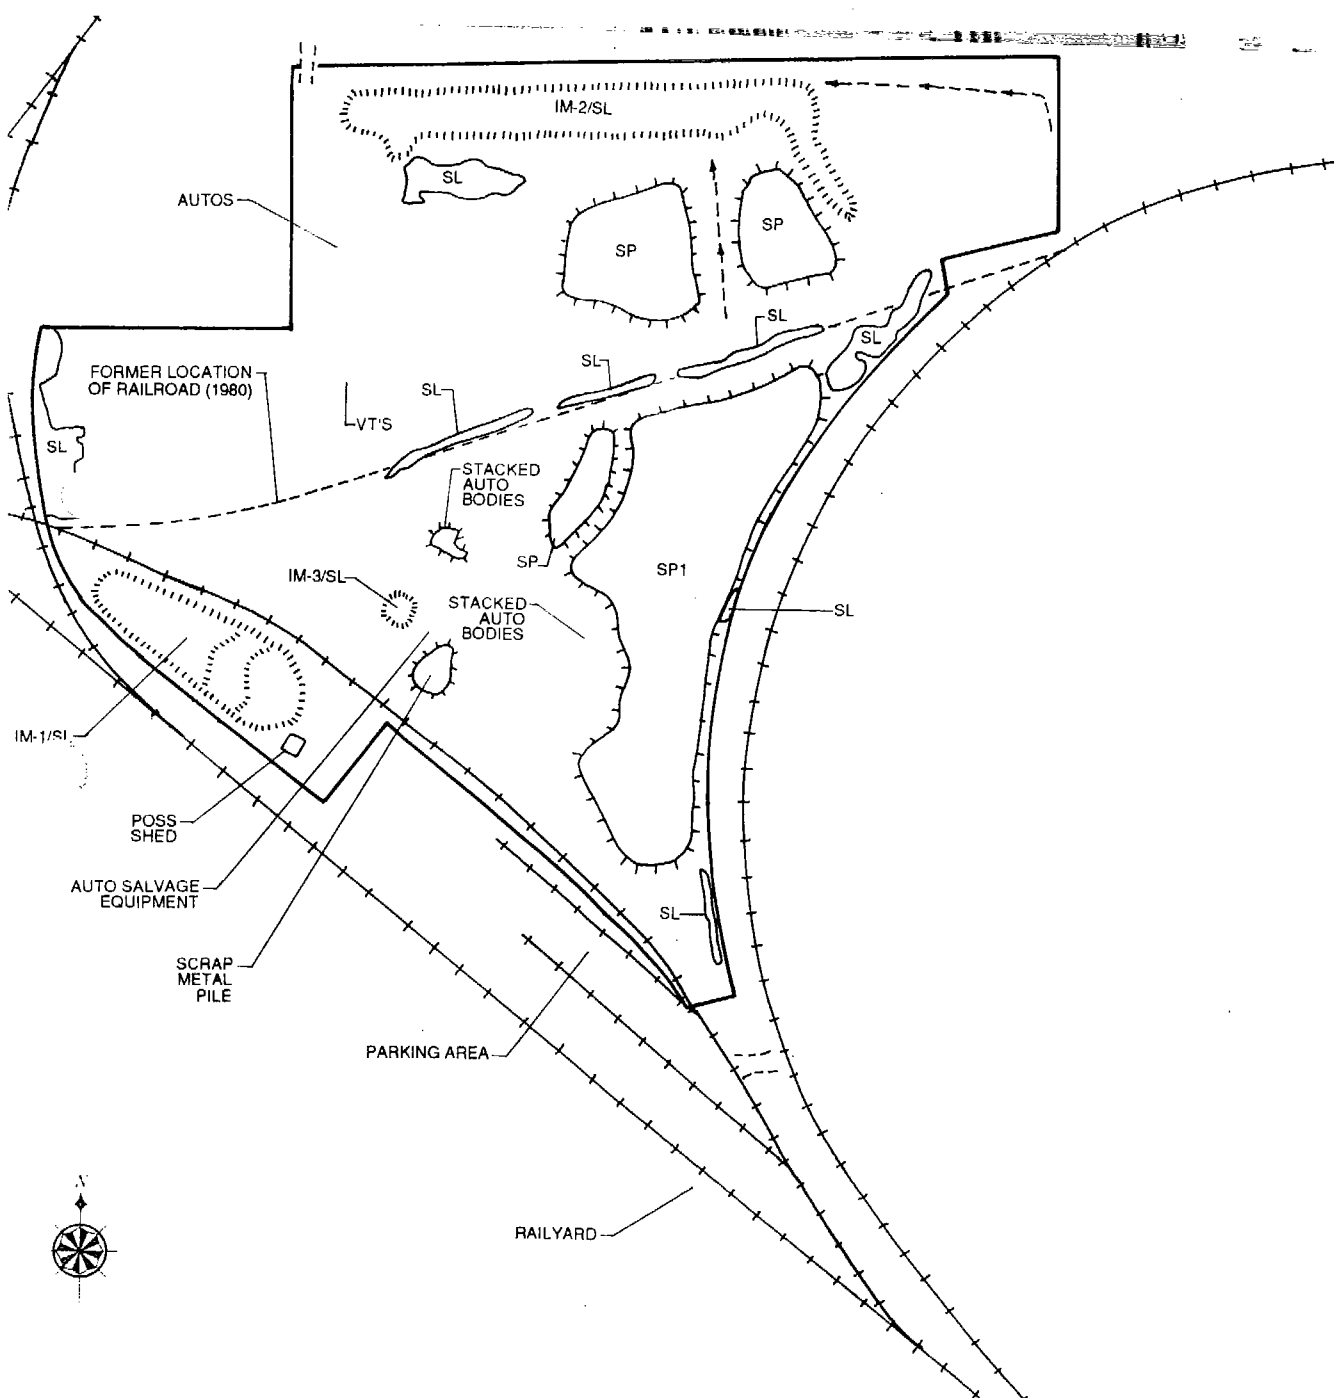
Midwest Metallics site, April 20, 1994. Approximate scale 1:3,100.

The site continues to be in operation. Liquid-filled impoundment IM-2/SL now contains one cell. No changes are noted in liquid-filled impoundment IM-1/SL and the impoundment annotated IM-3 in 1992 now contains liquid and is annotated as IM-3/SL. Storage pile SP1 has changed in configuration since 1992.

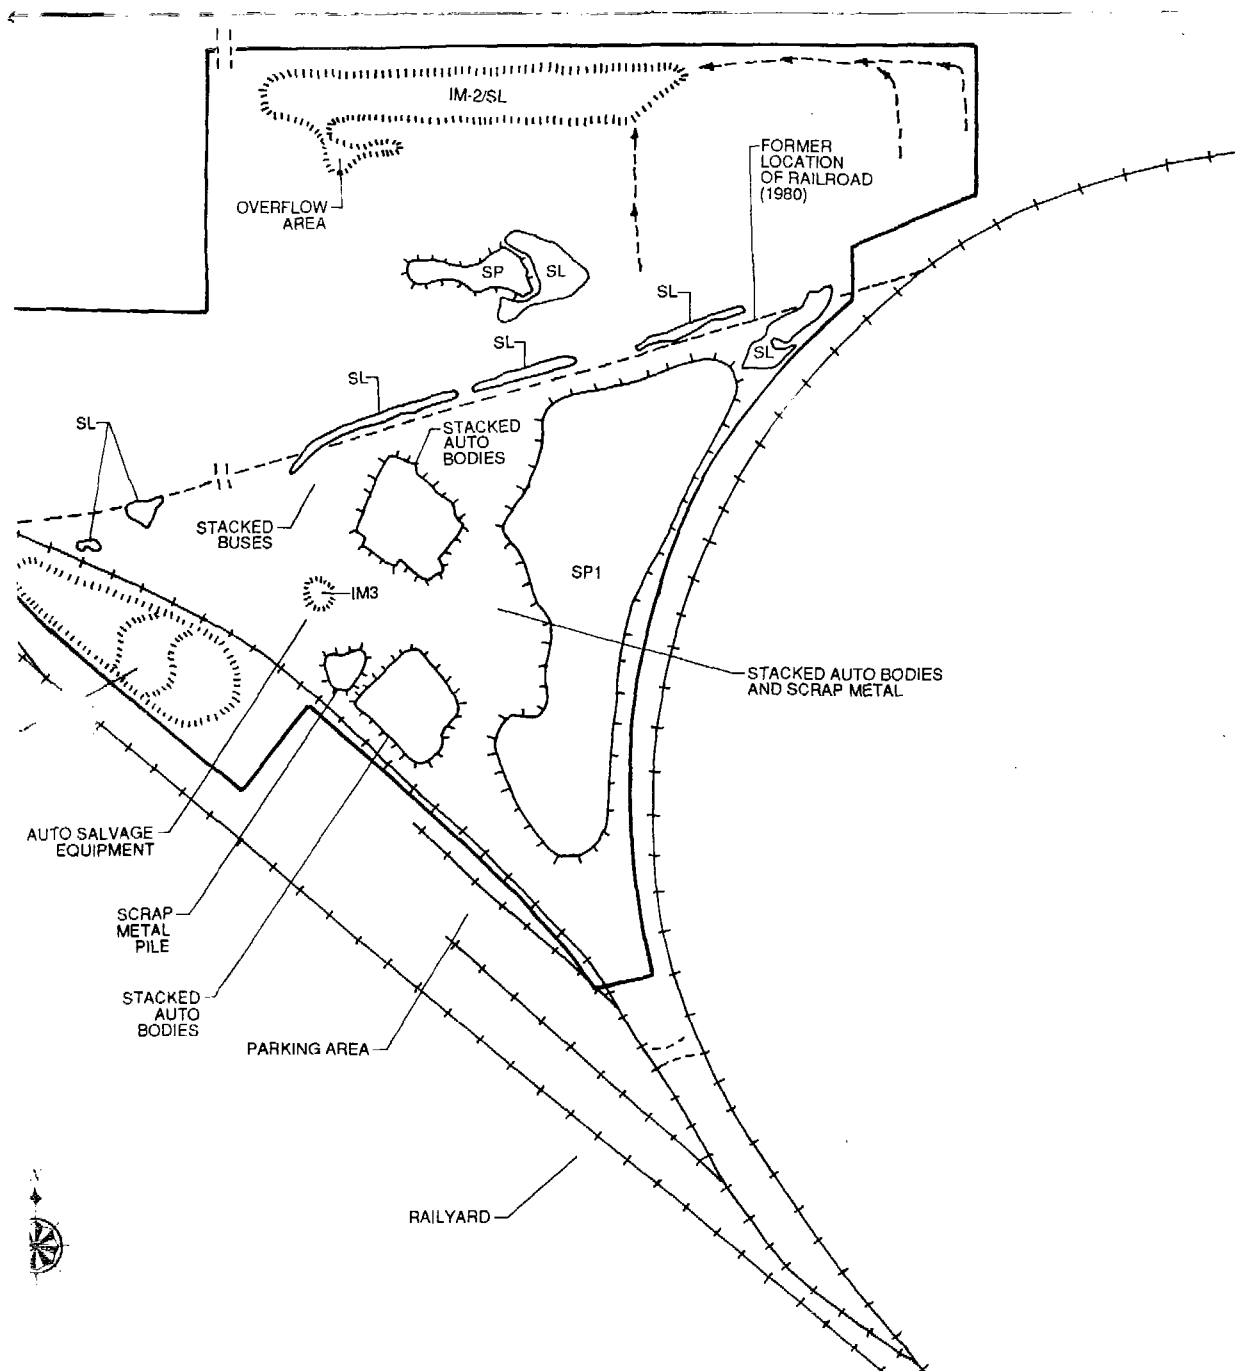
Midwest Metallica site, April 2, 1997. Approximate scale 1:3,100.

The site continues to be in operation. Liquid-filled impoundment IM-2/SL has overflowed its berm and now extends to the area of standing liquid observed south of it in 1994. Another drainage segment which trends in a northerly direction toward the drainage segment previously observed, is visible at the northeast corner of the site. Liquid-filled impoundment IM-1/SL now contains three cells and the liquid-filled impoundment annotated IM-3/SL in 1994 is now dry and annotated IM-3. Storage pile SP1 has changed in configuration since 1994.

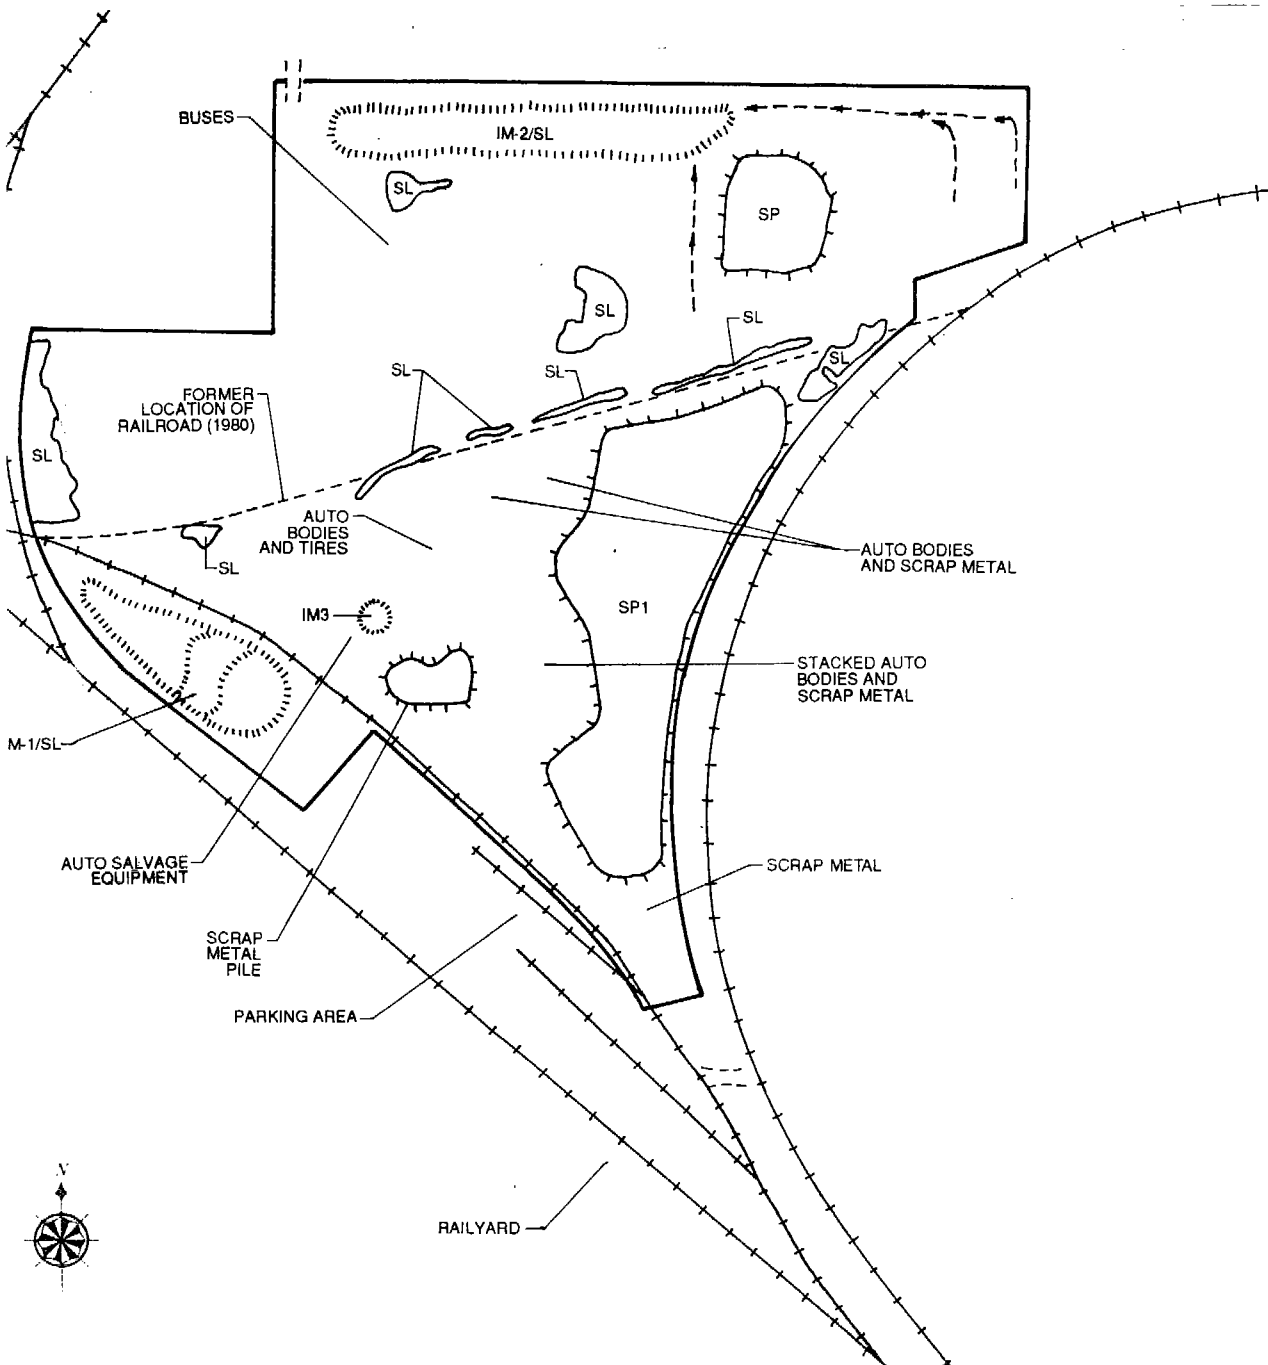
Midwest Metallics site, March 24, 1998. Approximate scale 1:3,400.

The site continues to be in operation. Liquid-filled impoundment IM-2/SL has dried up slightly, leaving behind an area of standing liquid to the south of it. No changes are noted in liquid-filled impoundment IM-1/SL or the dry impoundment IM-3. No changes are visible in storage pile SP1.
